## Site Inspection Report Summary

**Property Address:** 6231 PA-88 Finleyville, PA 15332

**Inspection Date:** 06/10/2020

## **Photo Report of Koteles Garage**

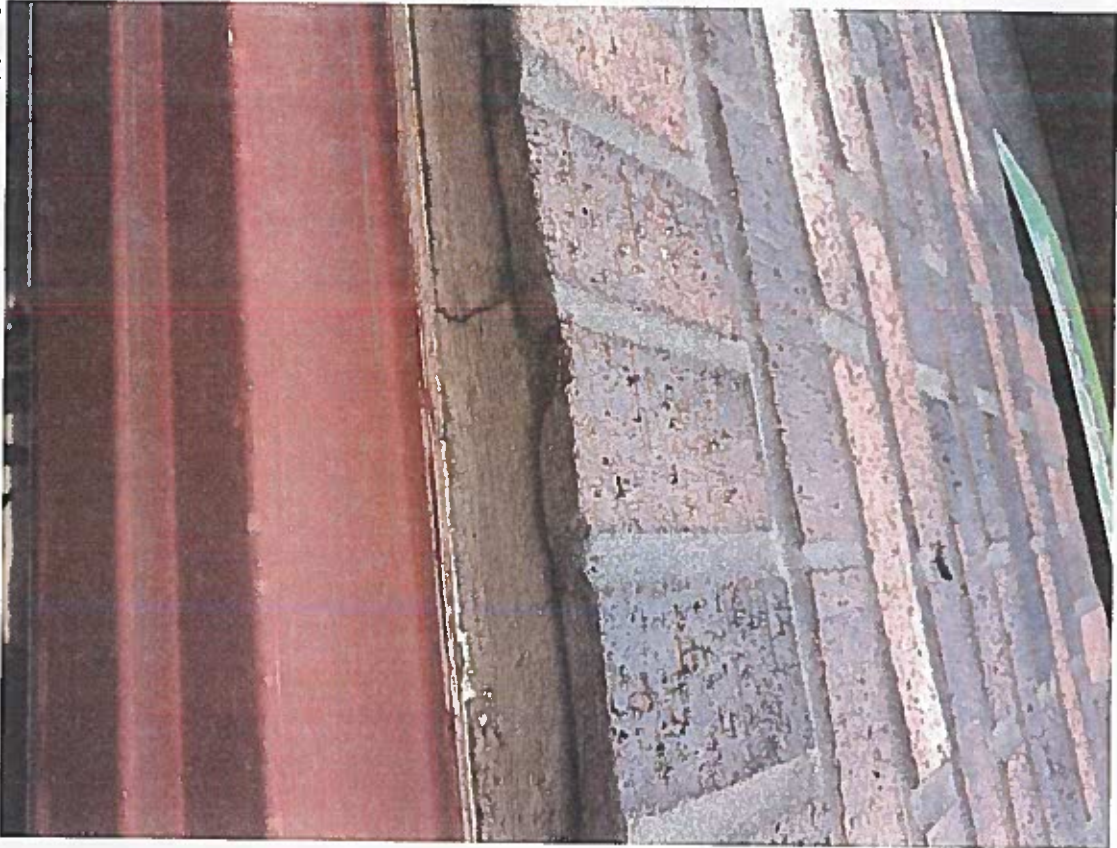
Cracking above the front entry door adjacent to the property's front garage bays.

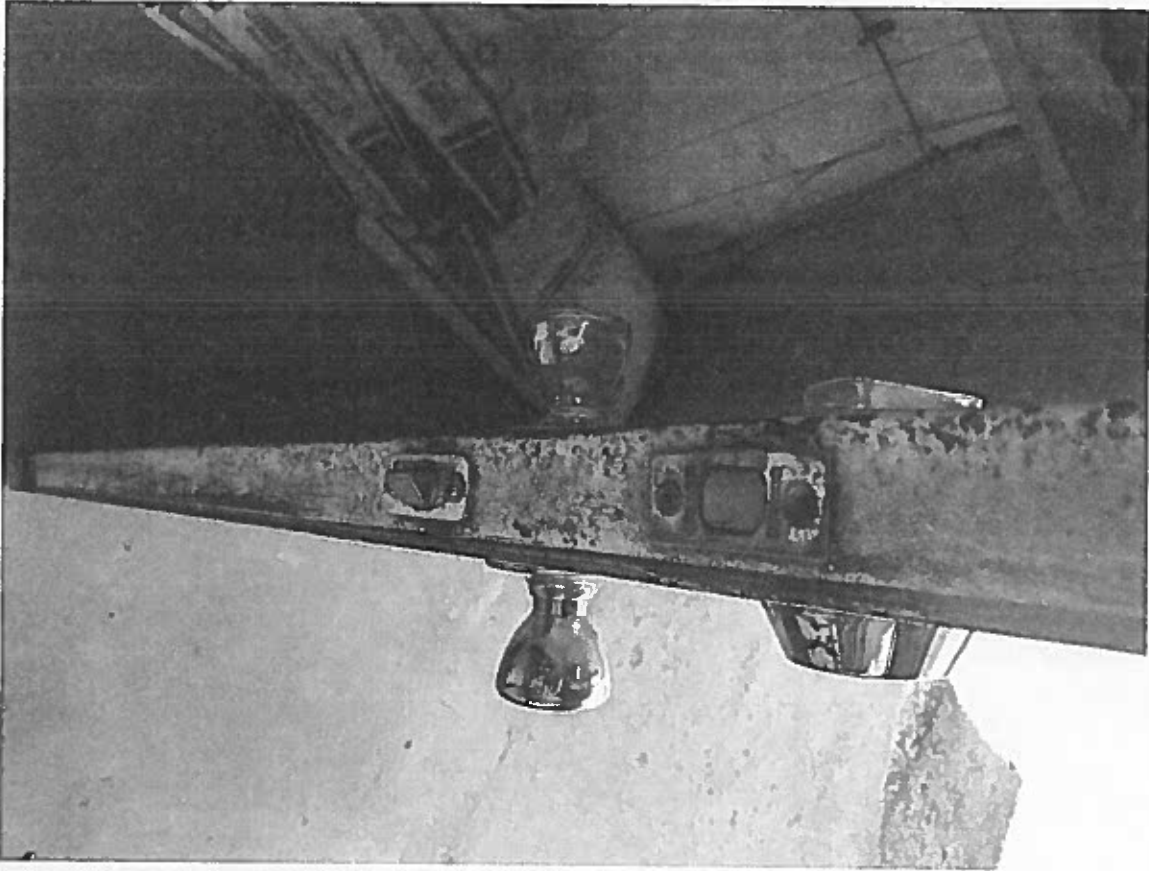
Extensive wear and tear on front entry door for customers. Rusty, needs repainted, damaged striker plate.

All of the doors for customer and employee access to the building had significant amounts of wear and tear. There are various amounts of visible rust on the steel portions of all the doors. It is recommended to repaint the doors. Multiple doors have striker plate damage. A door to access the rear service bays with tire storage has significant damage to the lower door plate. The white building access door at the far rear of the property has extensive rot around the door trim.

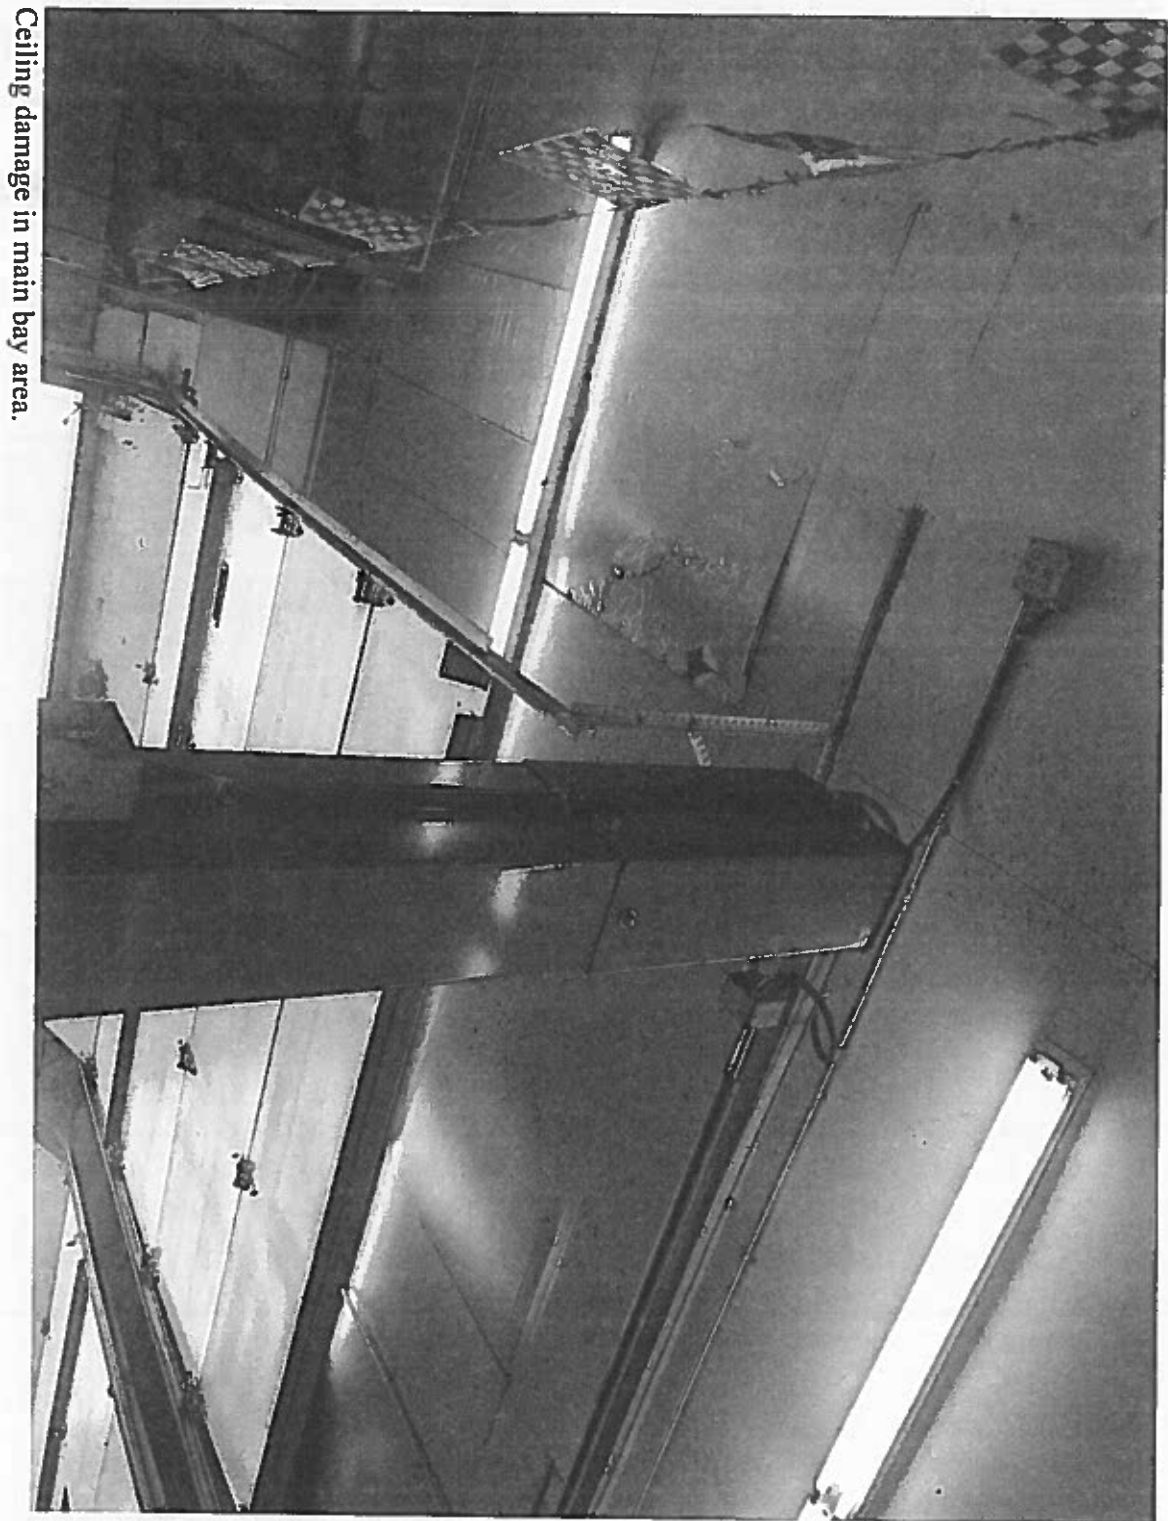
Ceiling damage in main bay area.

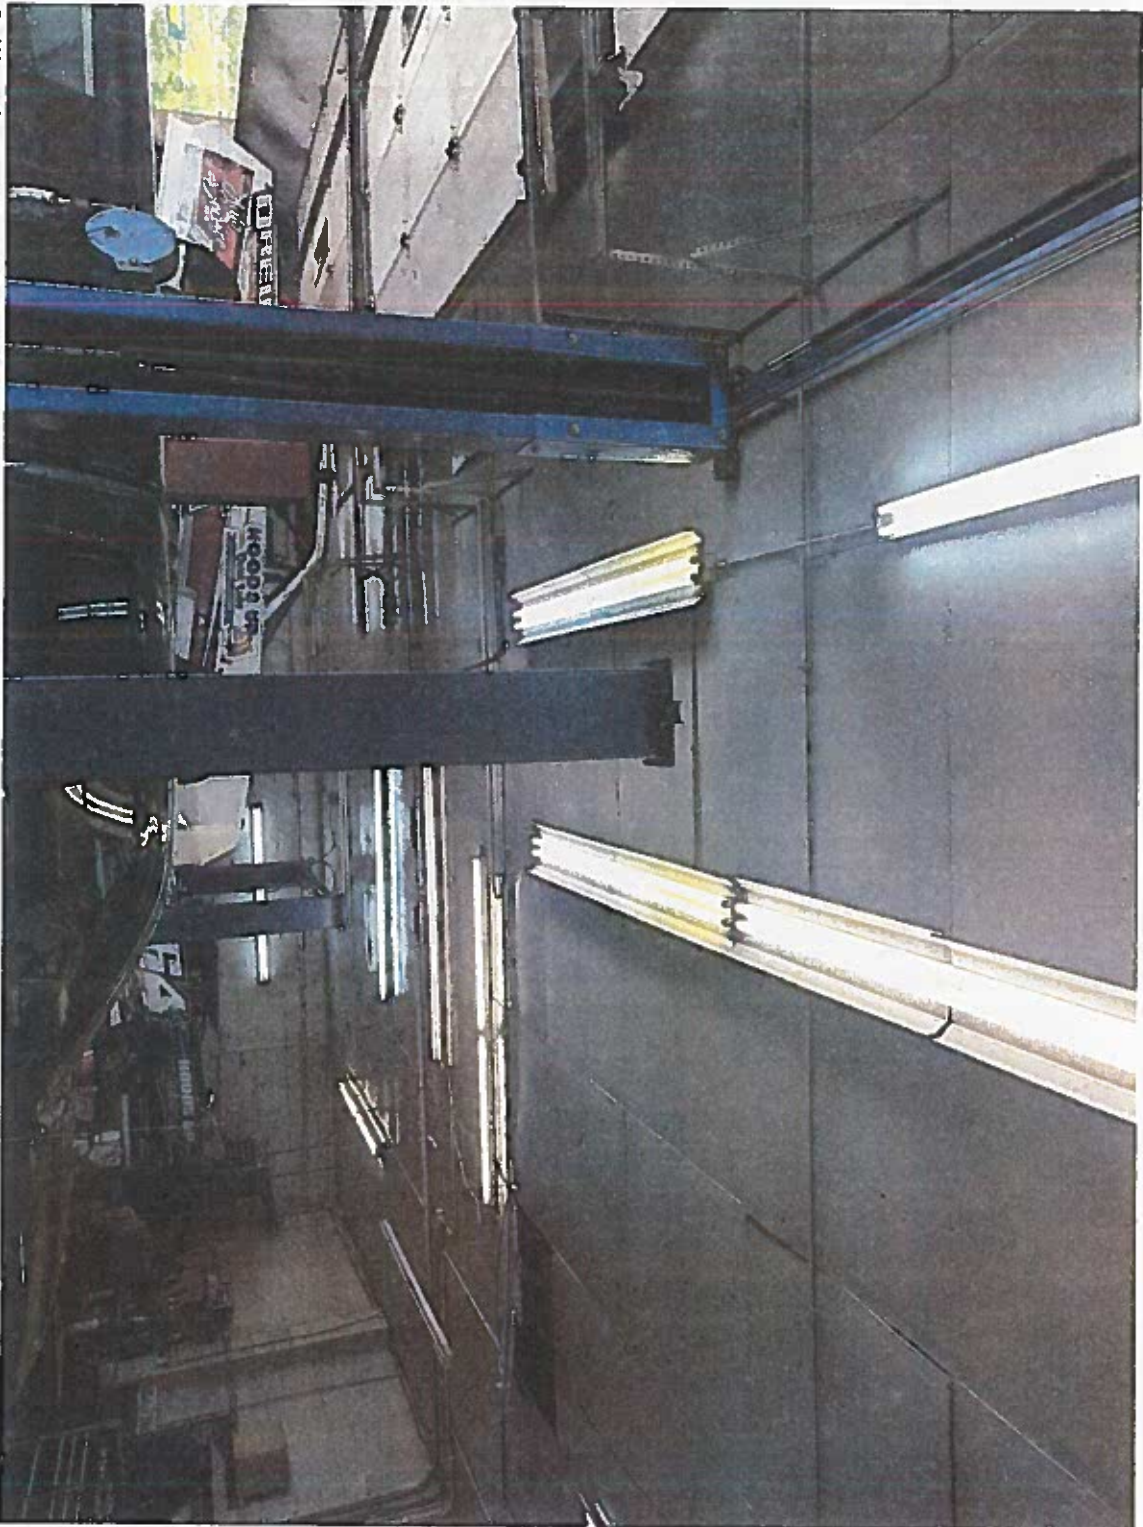
Ceiling damage in main bay area.

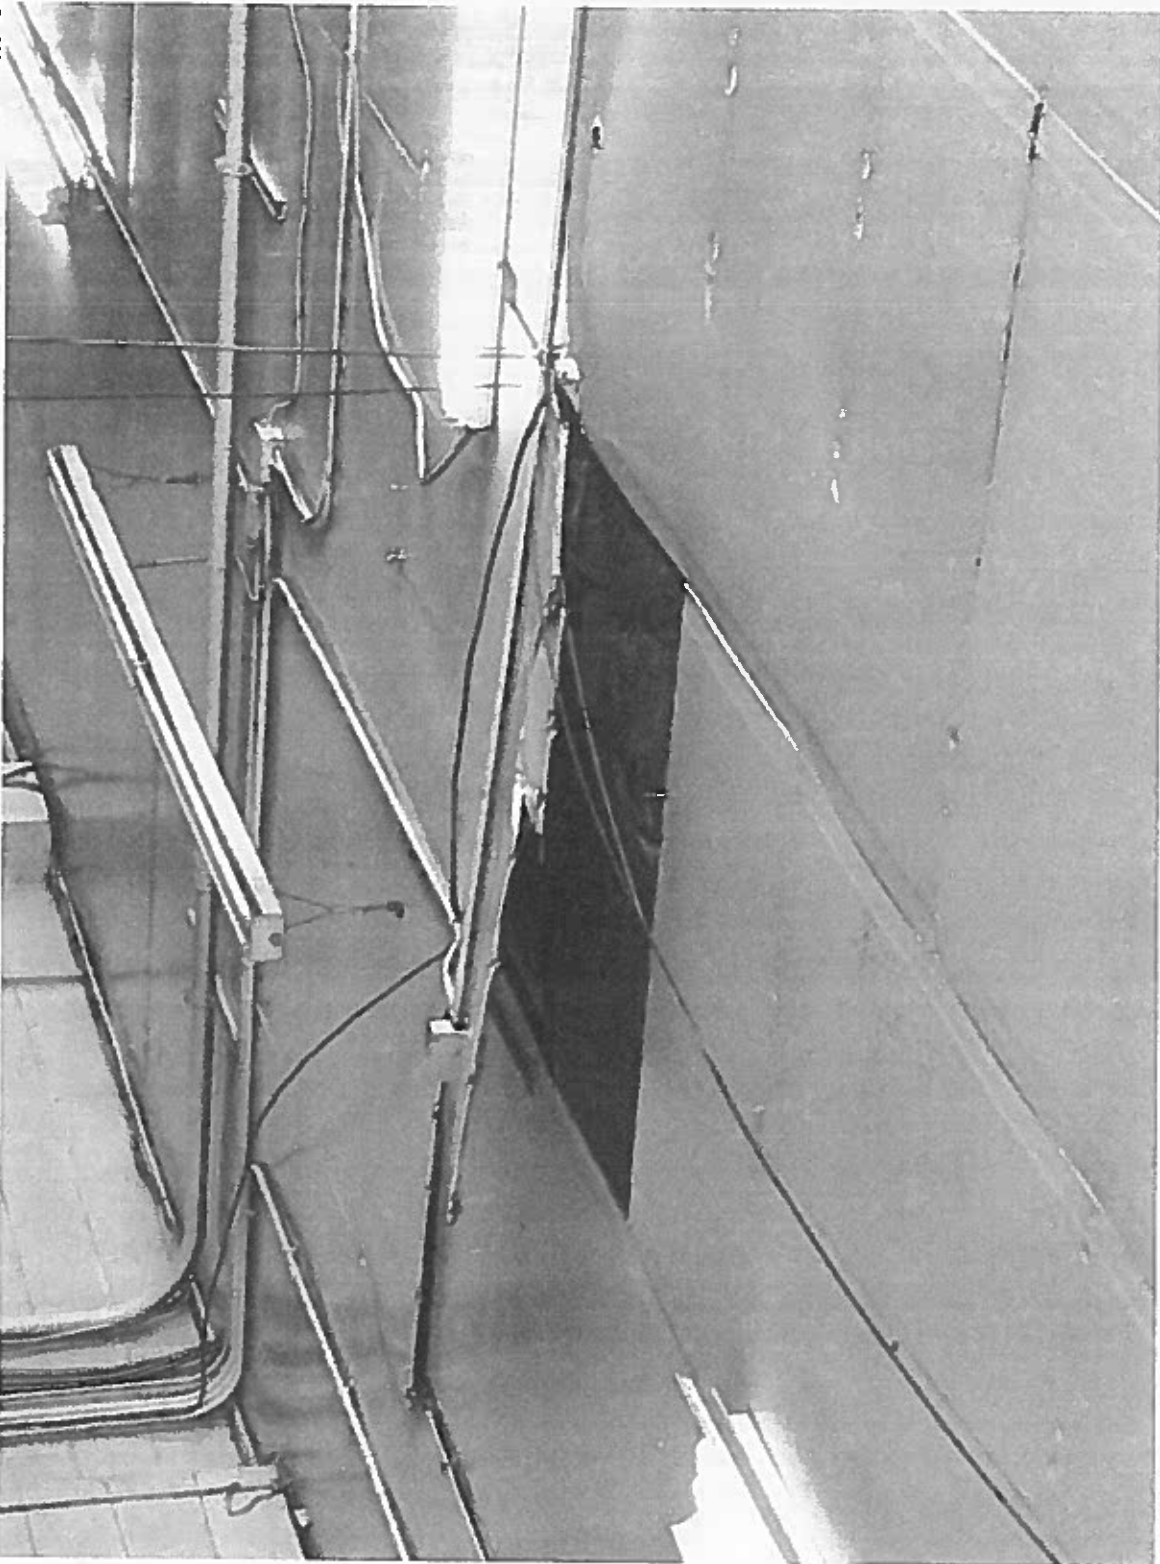
Ceiling damage in main bay area.

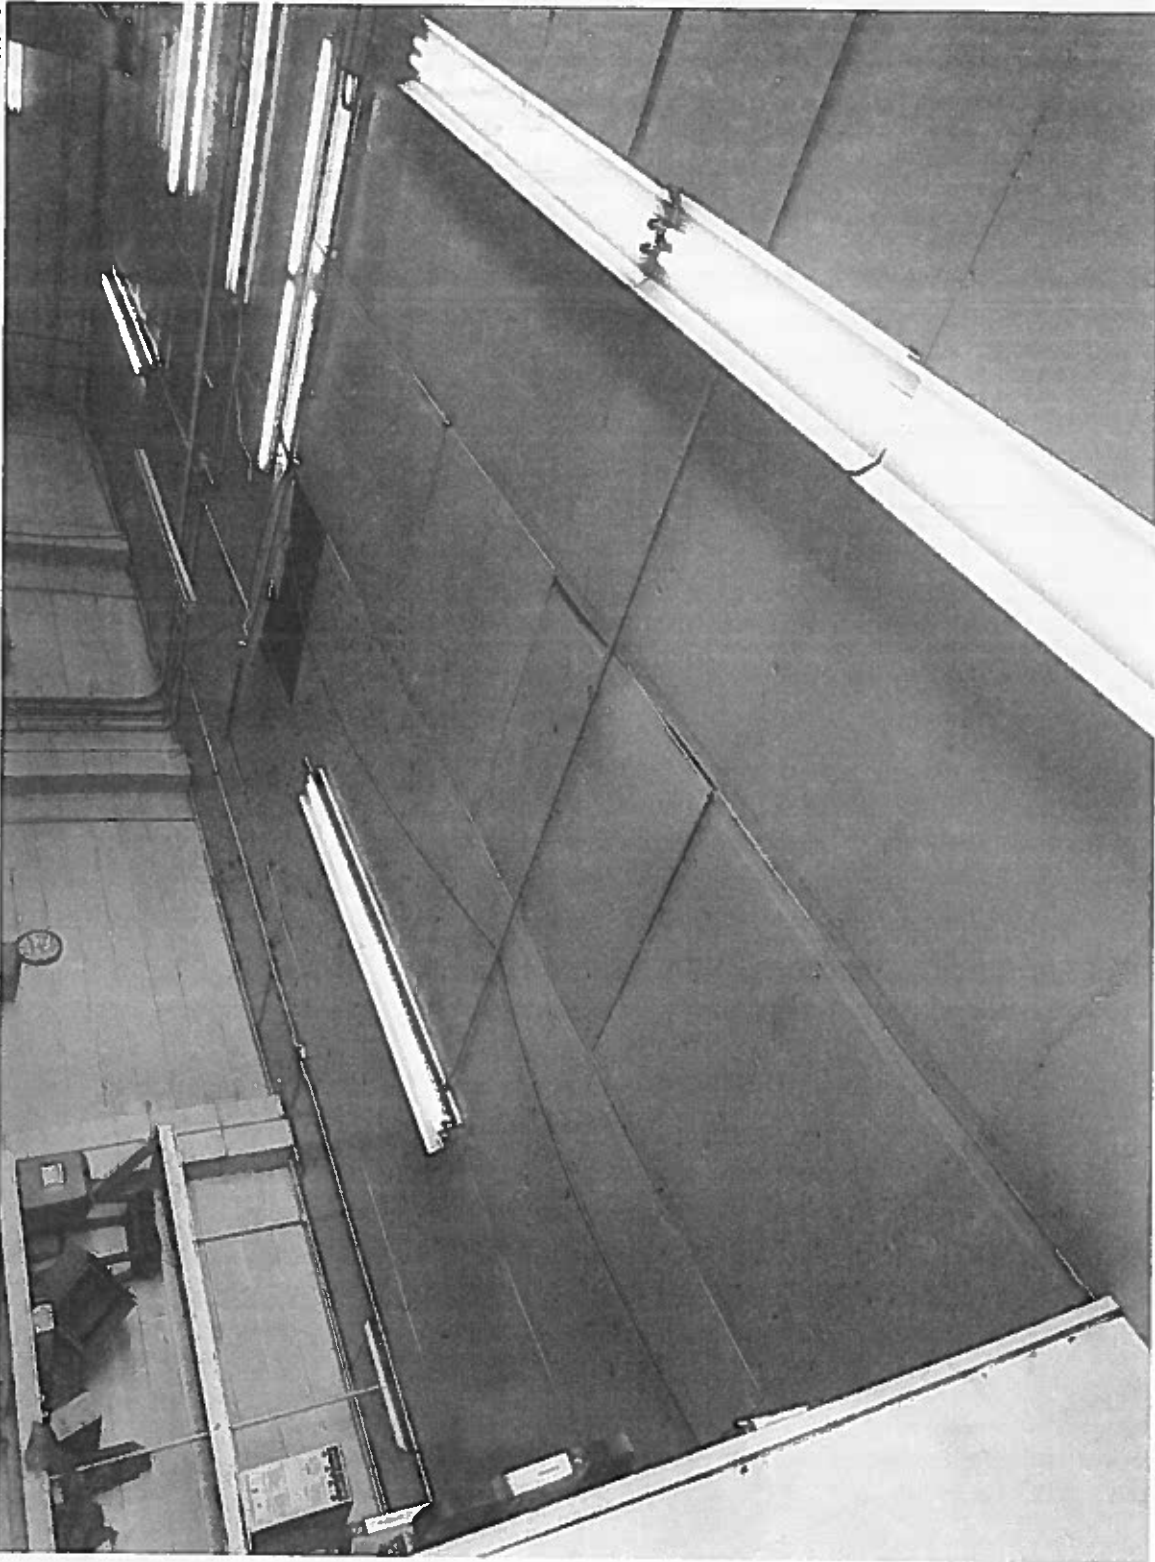
Ceiling damage in main bay area.

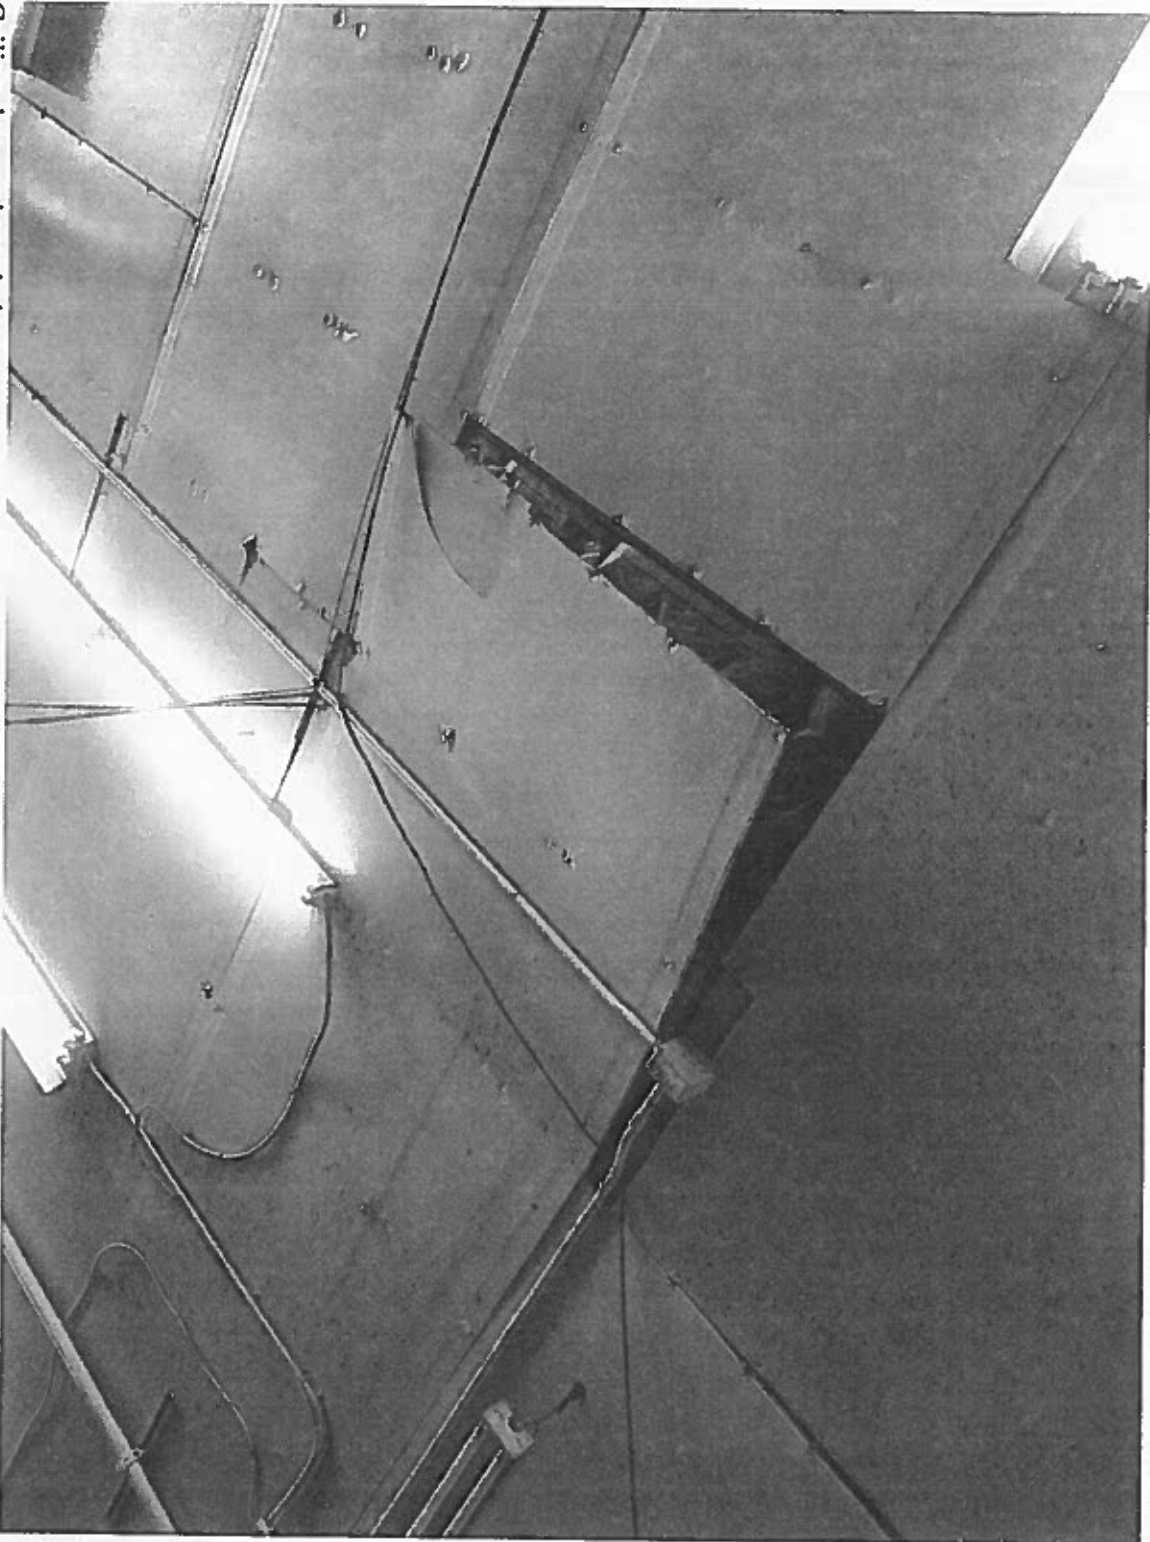
Ceiling damage in main bay area.

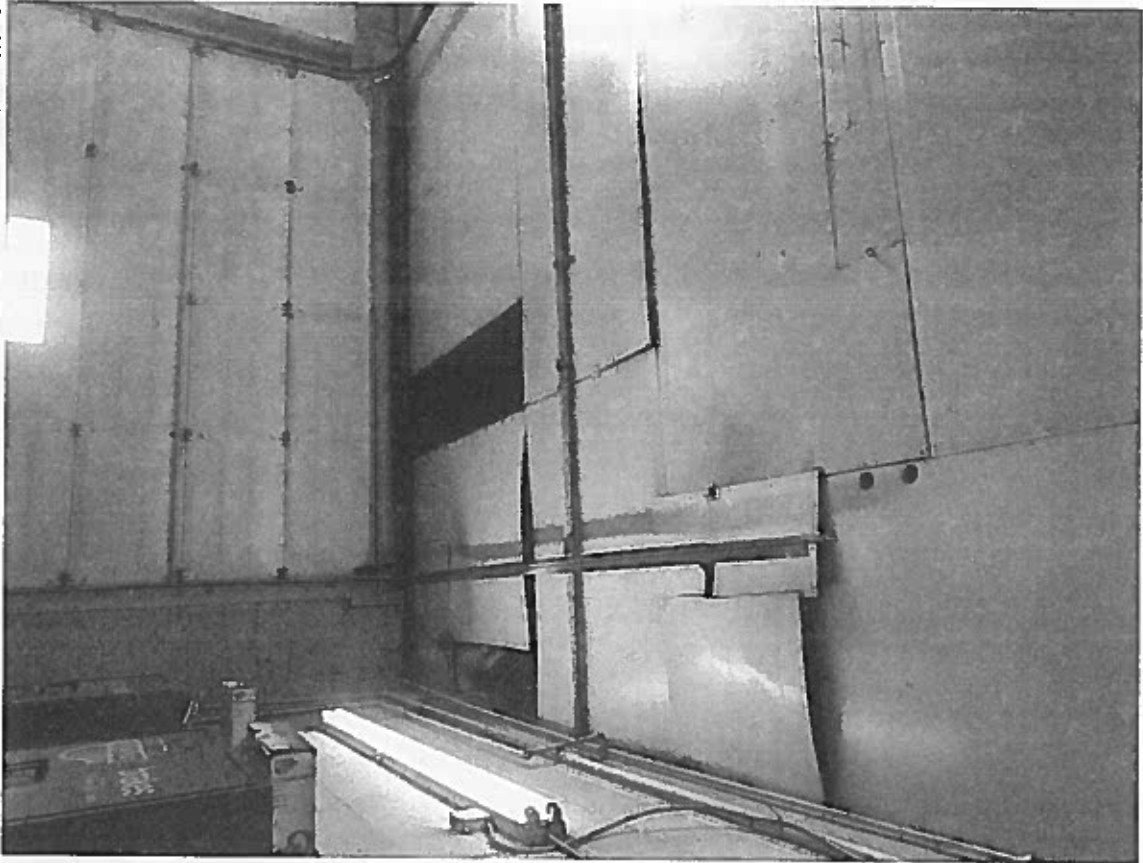
Ceiling damage in main bay area.

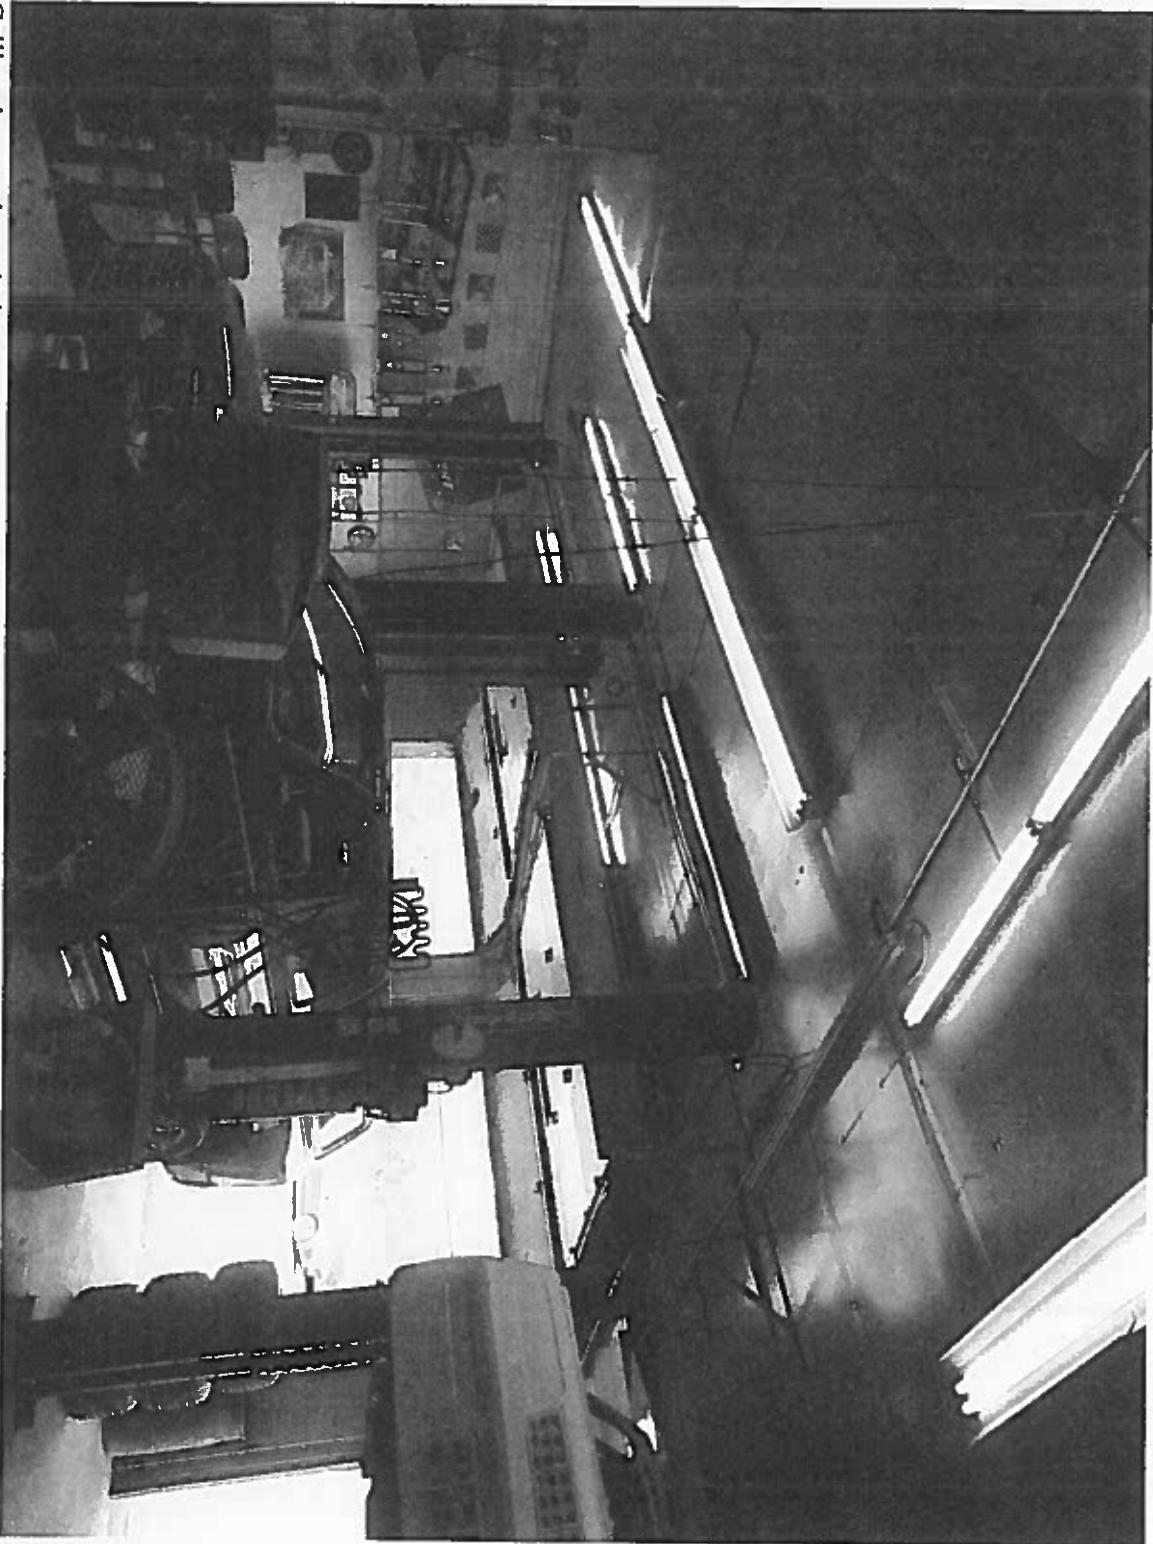
Ceiling damage in main bay area.

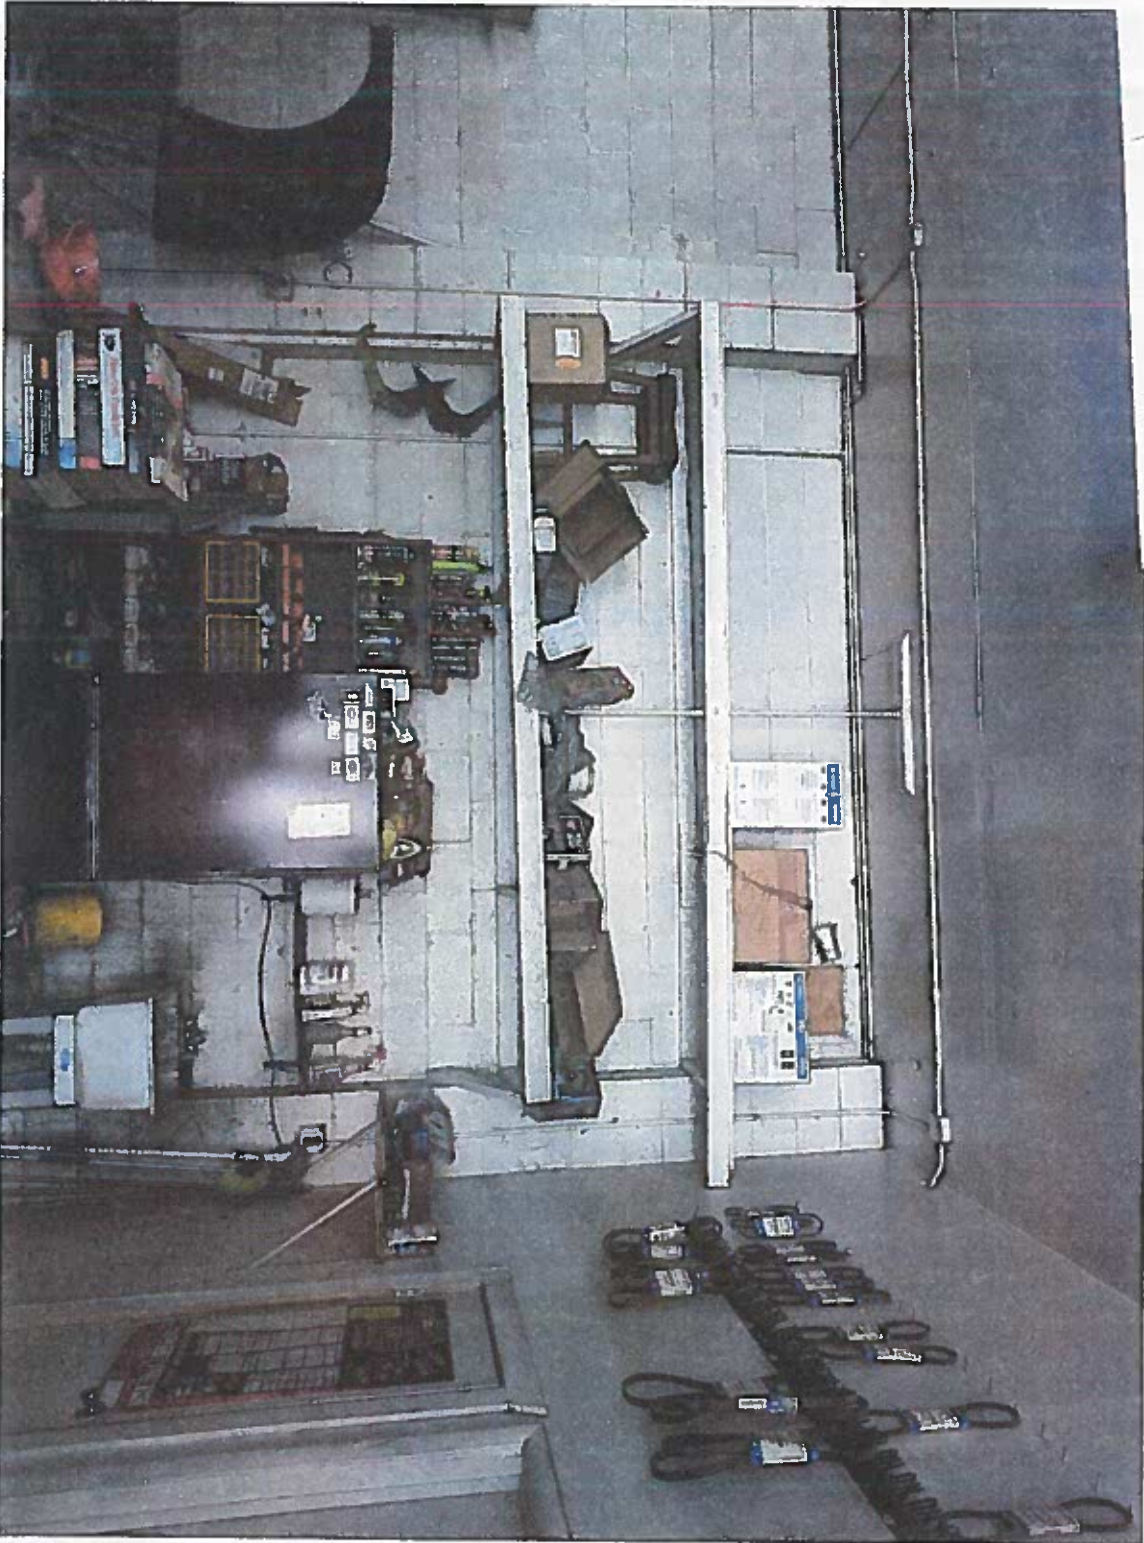
Crooked shelving. Previously overloaded?

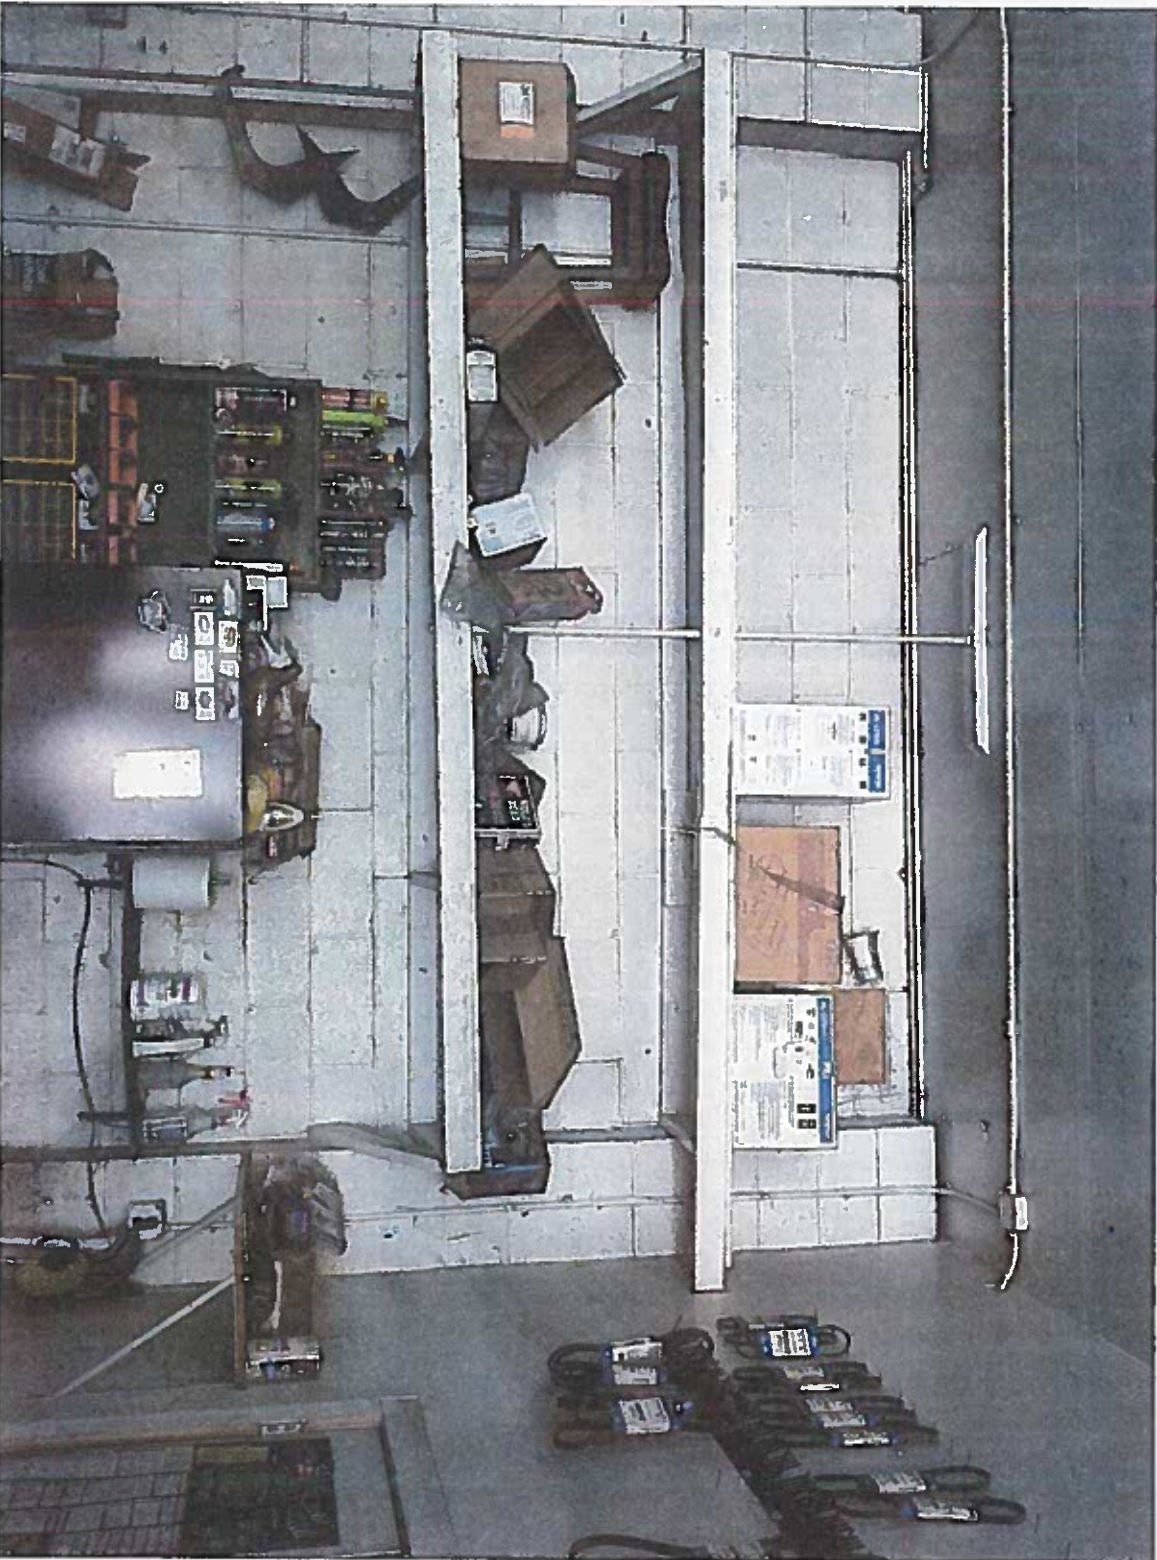
Crooked shelving. Previously overloaded?

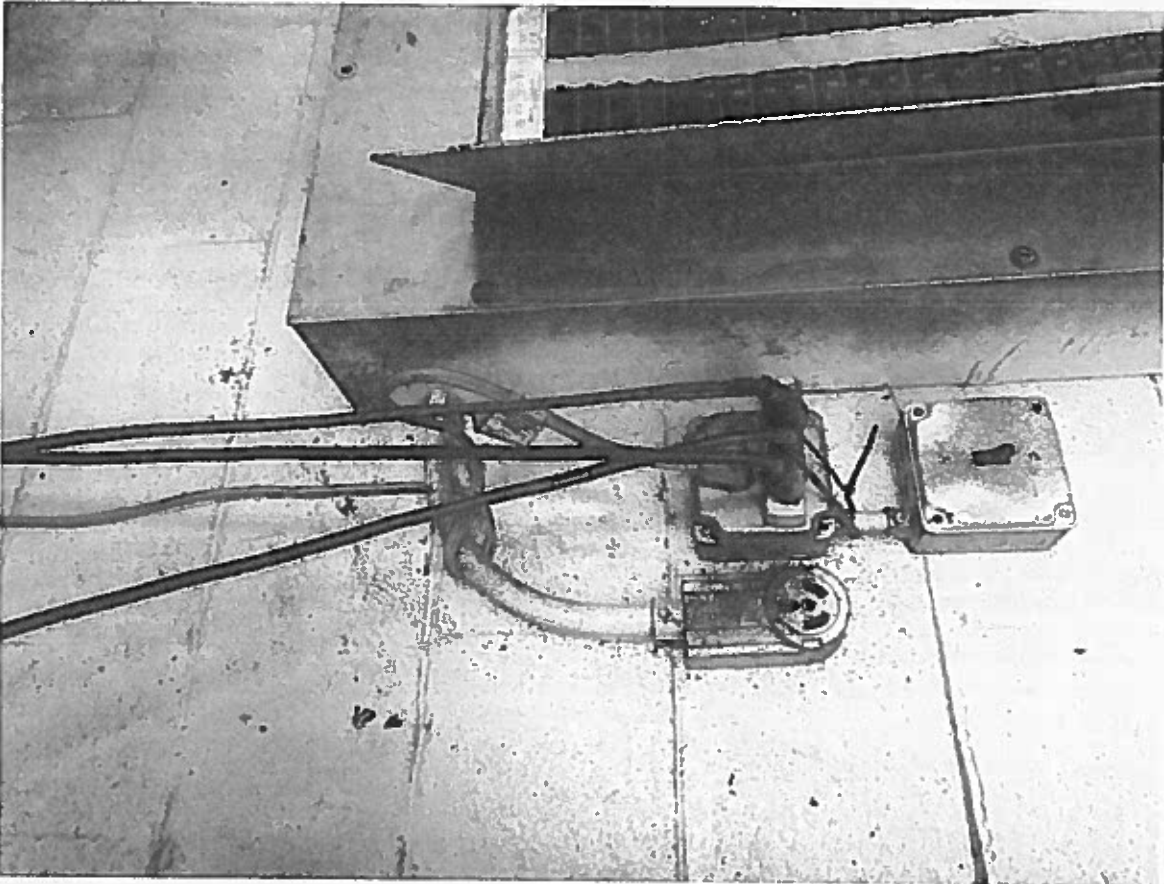
In the front service bay area, one area had a large amount of equipment plugged into one electrical circuit.

Highly loaded single circuit.

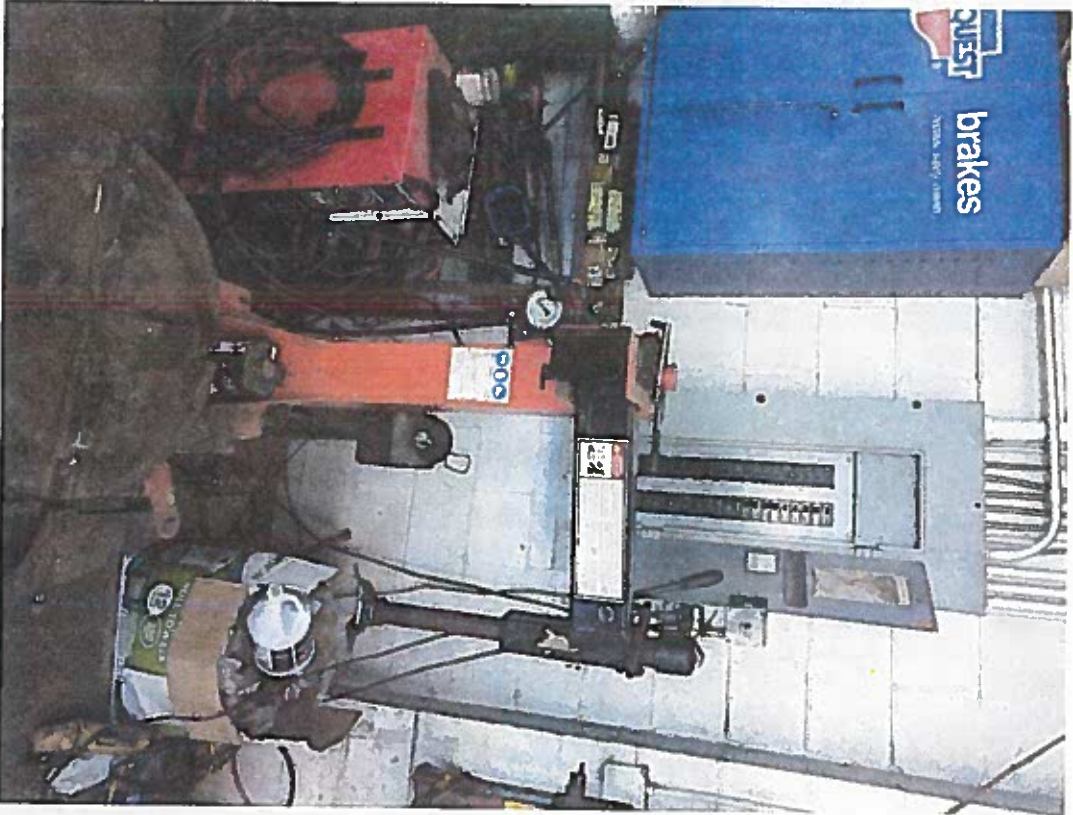
Highly loaded single circuit.

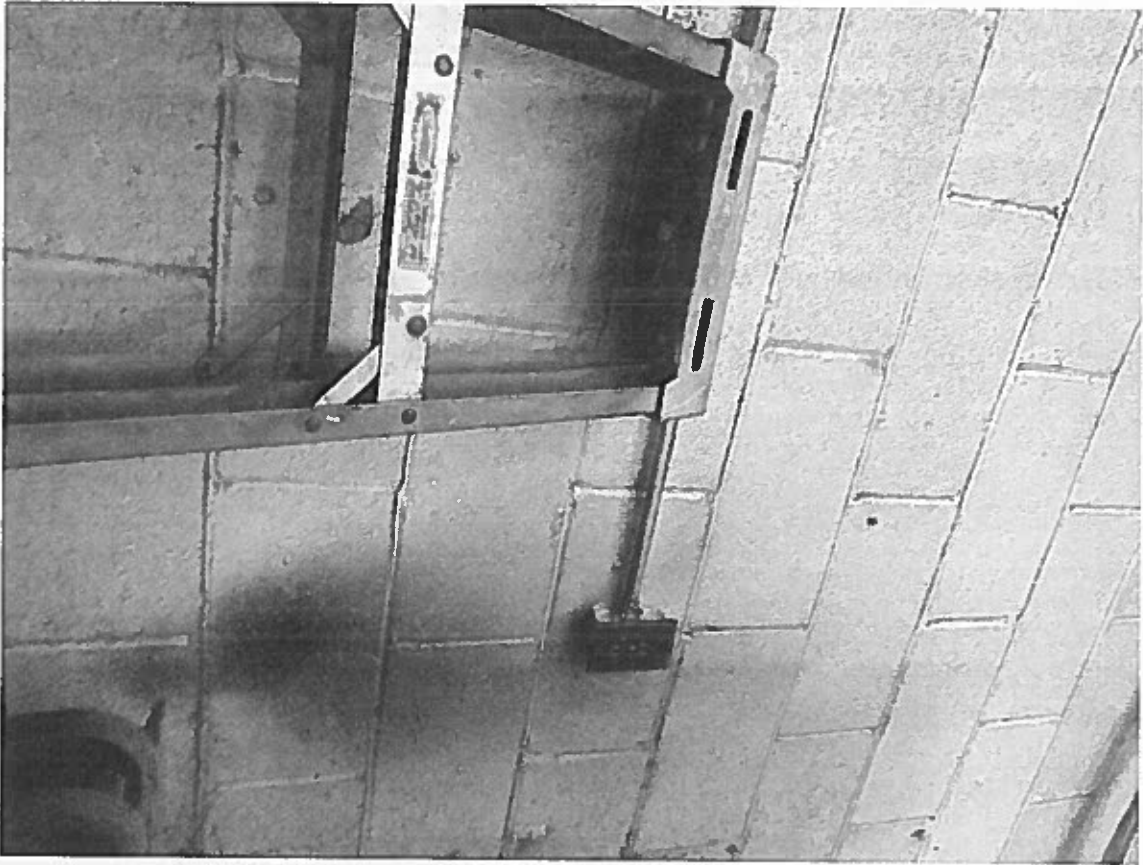
Burn mark or exhaust located on wall of the main bay.

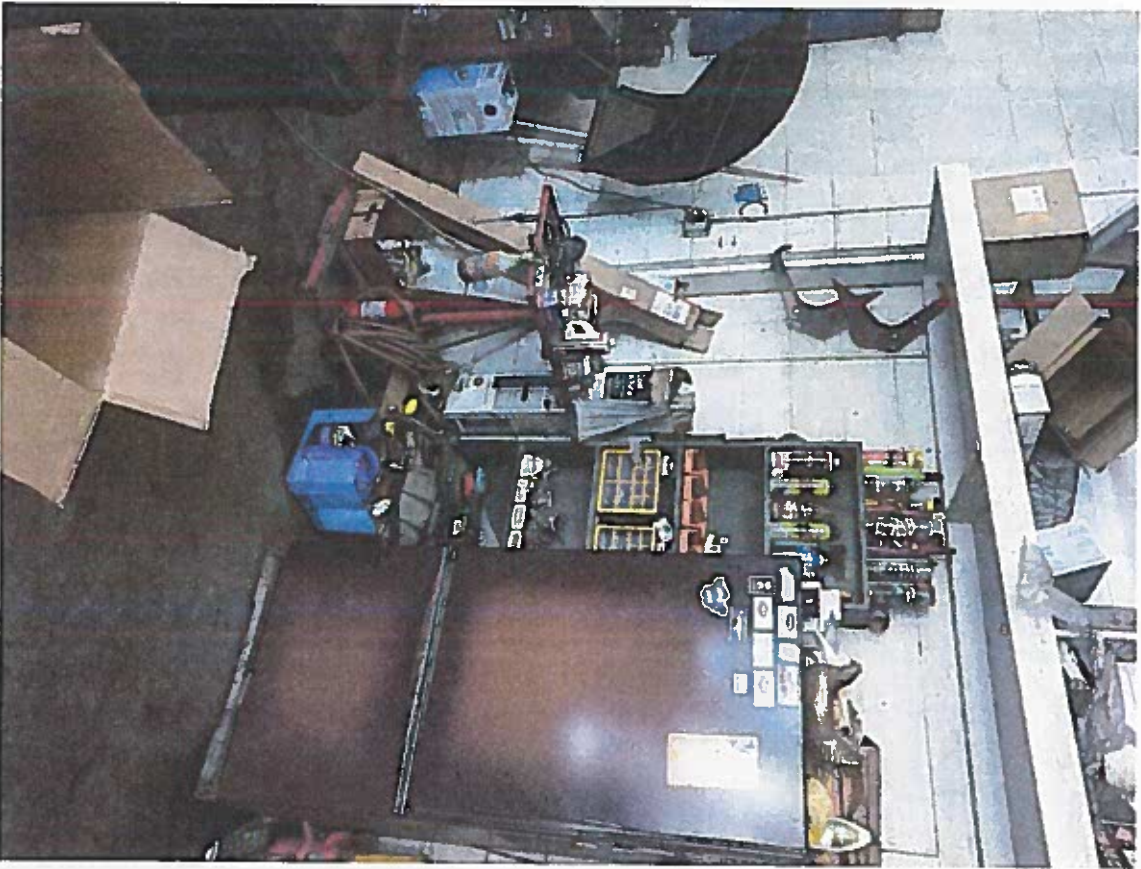
In the front maintenance bays, one small fire extinguisher was found during the course of inspection in an unmarked location on the floor. This area is filled with miscellaneous items not related to fire suppression. Fire extinguishers should be clearly marked and mounted on the wall.

Only fire extinguishers found in the main bay placed in misc equipment pile on floor. Extinguishers not clearly marked where located.

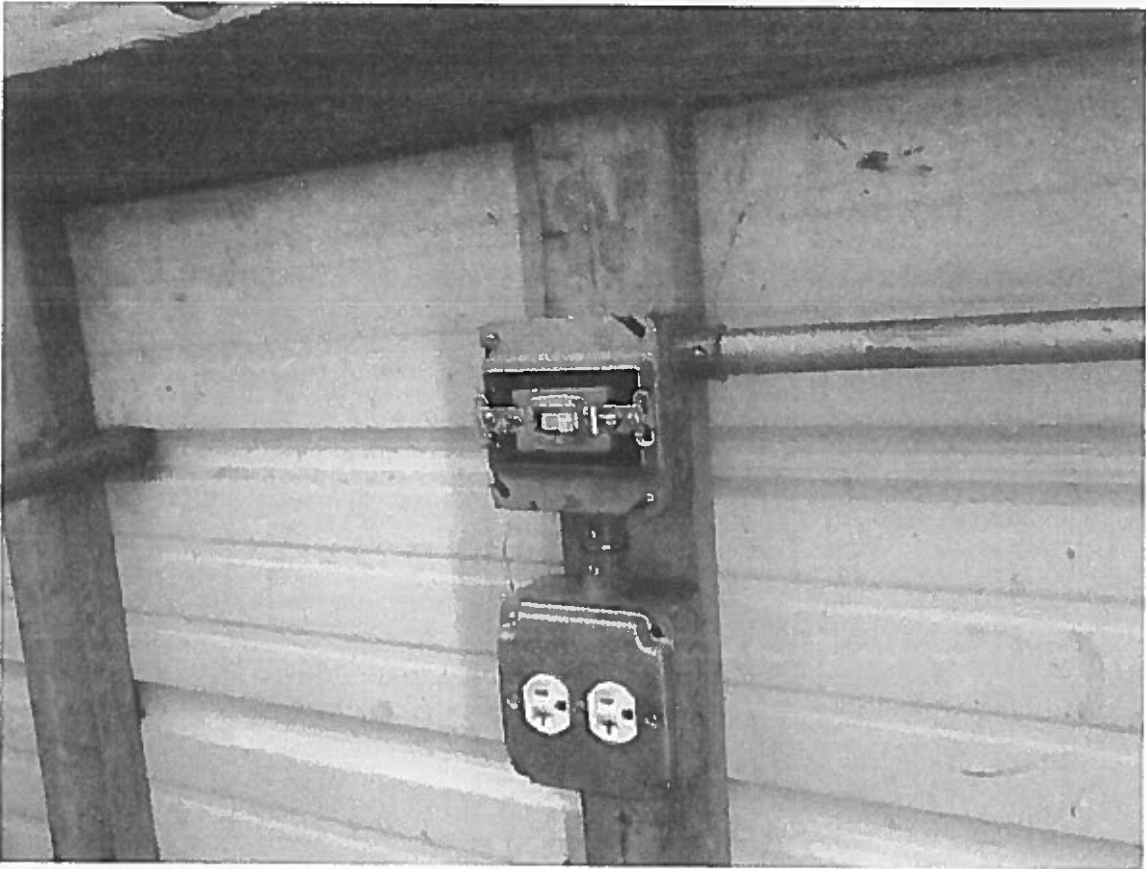
In the white building at the rear of the property, the light switch closest to the access door to the building was missing a light switch cover.

Missing light switch cover in rear white building.
